# Ultimate Quality Assurance on Liner Installation by Using State of the Art Electric Leak Location Technologies

Silverio Prota<sup>1</sup>, Marcos Diaz<sup>1</sup>, Abigail Beck<sup>2</sup>, Miguel Lomardo<sup>1</sup> and Anibal Zeballos<sup>1</sup>

1. Anddes Argentina

2. TRI Environmental, USA

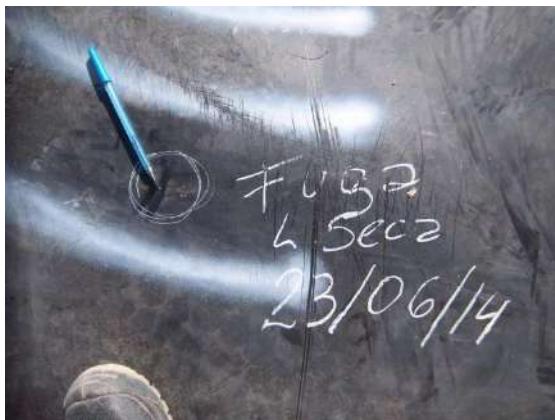
In both sites several small (1 cm) to very small leaks (0.5 mm) were detected, improving the quality of the system's construction. Most of these leaks were not visually detectable.

**Figure 12** Site #1 Small Leak

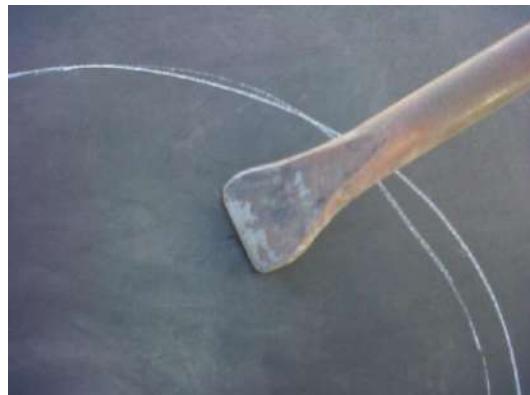
**Figure 13** Site #2 Small leak
