# Maximizing productivity in heap leach pads through dipole electrical leak location

## Abstract

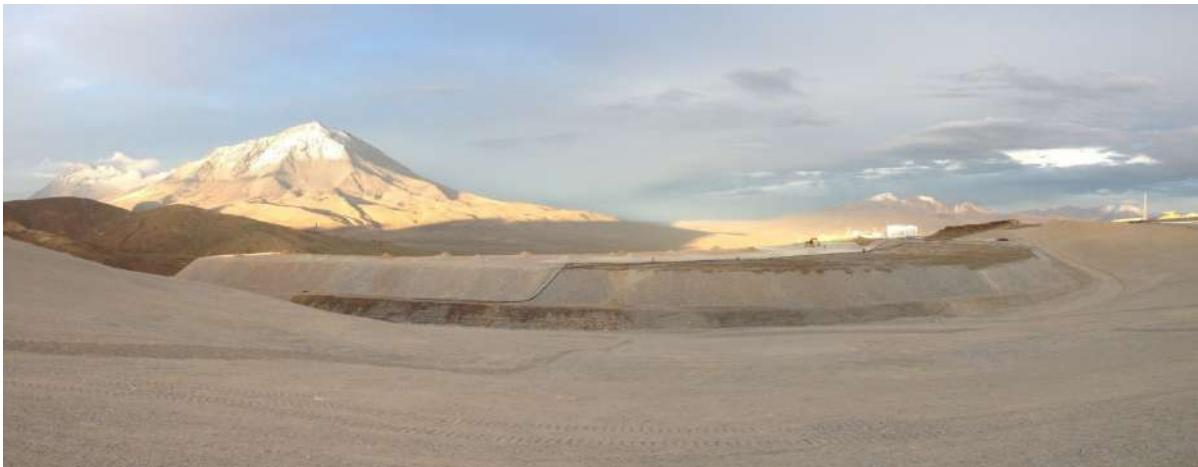
**Figure 1: Survey area general overview**

This heap leach pad was located in the Andes Mountains, at 4,400 m above sea level (masl). Figure 1 shows the area general overview. Weather at this site is generally dry, with a rainy season from December through February. The pad area to be surveyed was 110,000 m<sup>2</sup>, with a schedule restriction of ten days to finalize

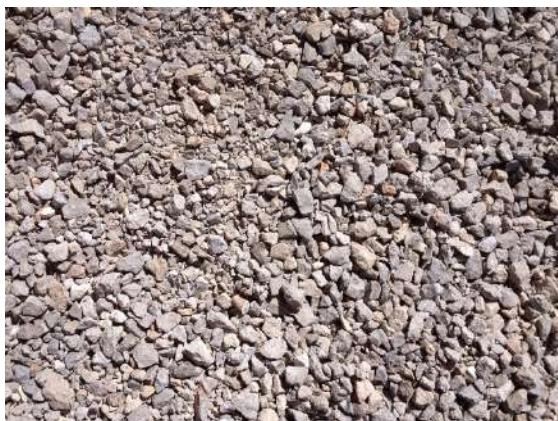
**Figure 2: Overliner material**

the project. Maximum slope was 2.5H: 1V, overliner material was high-grade ore with a minimum thickness of 0.6 m and a maximum thickness of 1 m.

2.0 mm LLDPE geomembrane single liner was used, placed on top of 30 cm soil liner (1.3 E-07 cm/s) layer.

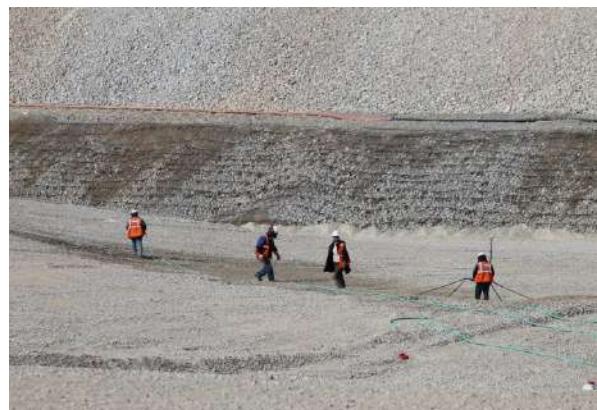
**Figure 3: Dipole survey**

When performing the dipole method on single-lined heap leach pads, the power source positive electrode (current injector) is inserted into the overliner above the geomembrane. The earth ground is wired

to the soil outside the pad. The dipole is used to measure the voltage throughout the survey area, using geophysical probes in direct contact with the earth (overliner). The voltage potential across the geophysical probes is measured and recorded.
